# **INDOOR AIR QUALITY ASSESSMENT**

**Community Action Headstart  
Building Two  
38 Old Groveland Road  
Haverhill-Bradford, Massachusetts**

Prepared by:  
Massachusetts Department of Public Health  
Bureau of Environmental Health Assessment  
August 2002

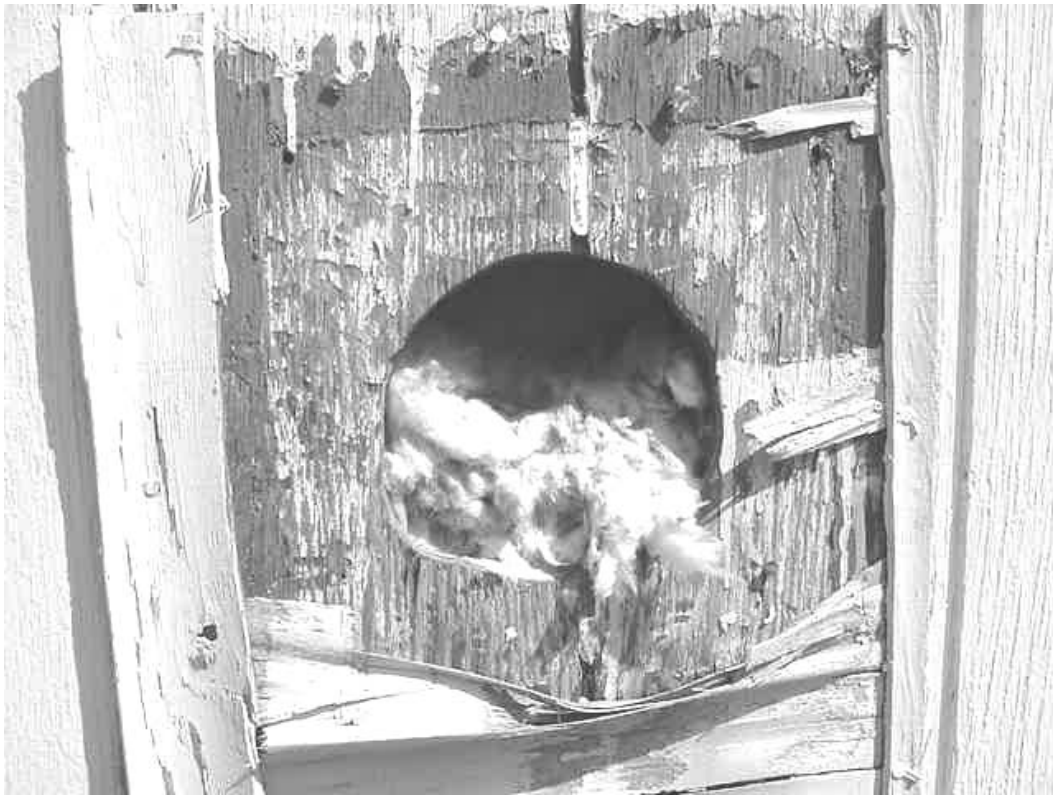
**Picture 1**

- Several holes in exterior walls of the building were noted (see Pictures 1 & 2), which can provide a source of water penetration as well as a means of entry for rodents/pests.

**Hole in Exterior Wall of Building Partially Stuffed with Fiberglass**

5. Seal holes in exterior walls. Replace/repair water damaged building materials. Examine the area around these areas for microbial growth. Disinfect areas of water leaks with an appropriate antimicrobial.

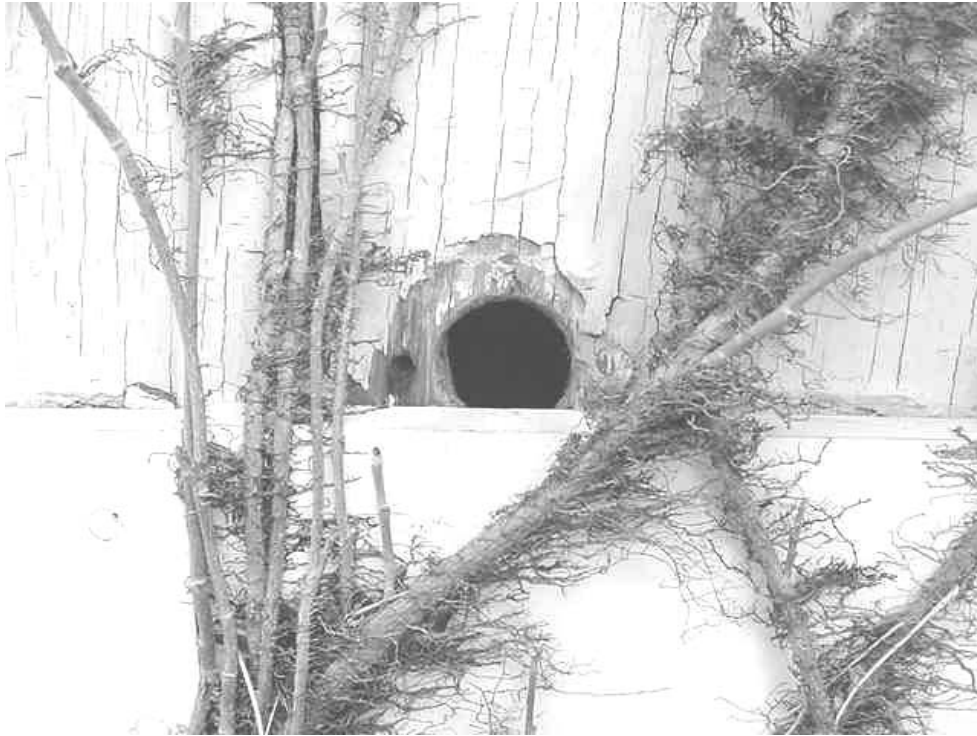
**Picture 2**

- Severely water-damaged wood along the eaves of the roof and around window frames was observed (see Picture 3).
- Plant growth was noted on exterior walls (see Pictures 2 & 4). The growth of plants against the exterior walls of the building can bring moisture in contact with building materials. This moisture contact can eventually lead to breaches of the building envelope resulting in water damage and subsequent microbial growth.

**Hole in Exterior Wall, Also Note Plant Growth on Side of Building**

6. Remove plant growths against the exterior wall/foundation of the building to prevent water penetration.
7. Change filters in window-mounted air conditioners as per the manufacturer's instructions to prevent the re-aerosolization of dirt, dust and particulate matter.

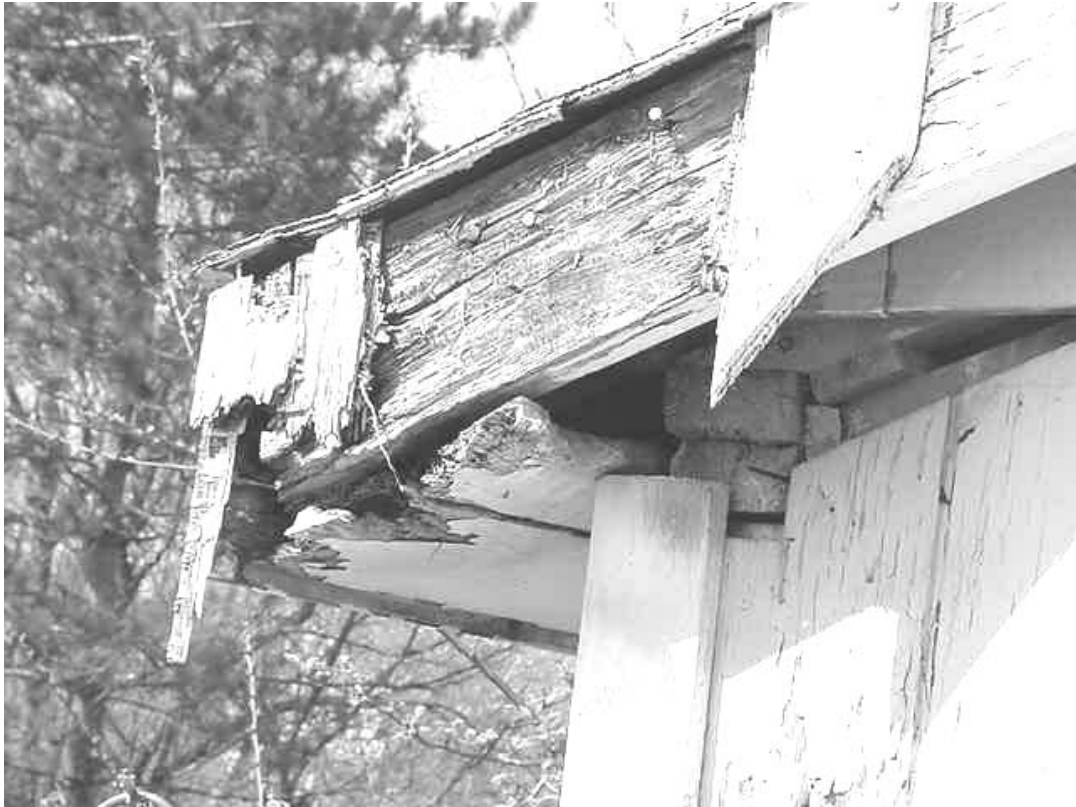
**Picture 3**

- The building is not equipped with a gutter/downspout system. Lack of roof drainage may allow rainwater to run down the exterior walls or pool on the ground against the building. Over time, this process can undermine the integrity of the building envelope and provide a means of water entry into the building.

**Rotted Wooden Eaves, Note Lack of Gutter/Downspout System**

1. Examine the feasibility of installing a gutter/downspout system.
2. Consult with architect and or general contractor regarding water tightness of the building primarily concerning the condition of siding and window frames. Have consultant assess water damaged building materials (e.g., eaves, ceilings, building envelope).

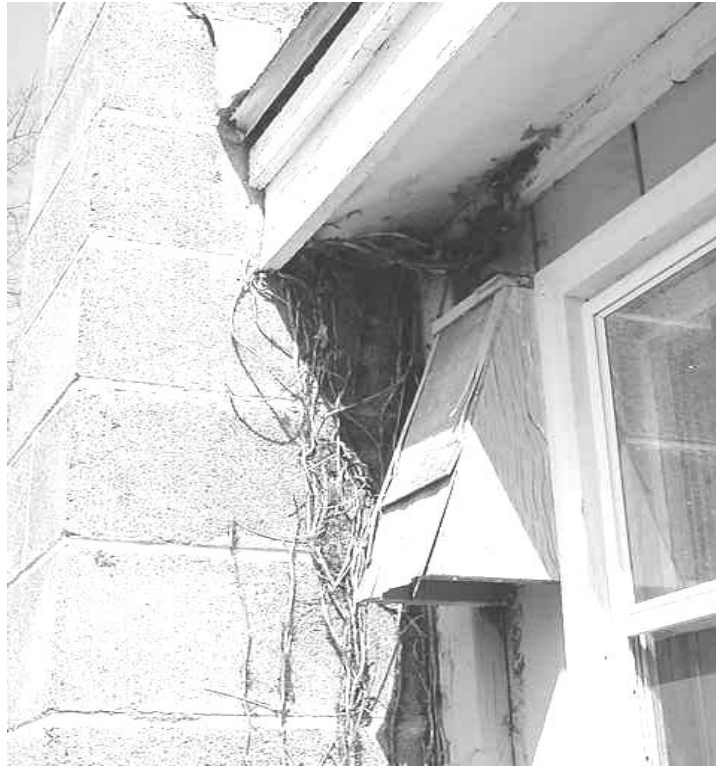
**Picture 4**

**Plant Growth up the Side of the Building**

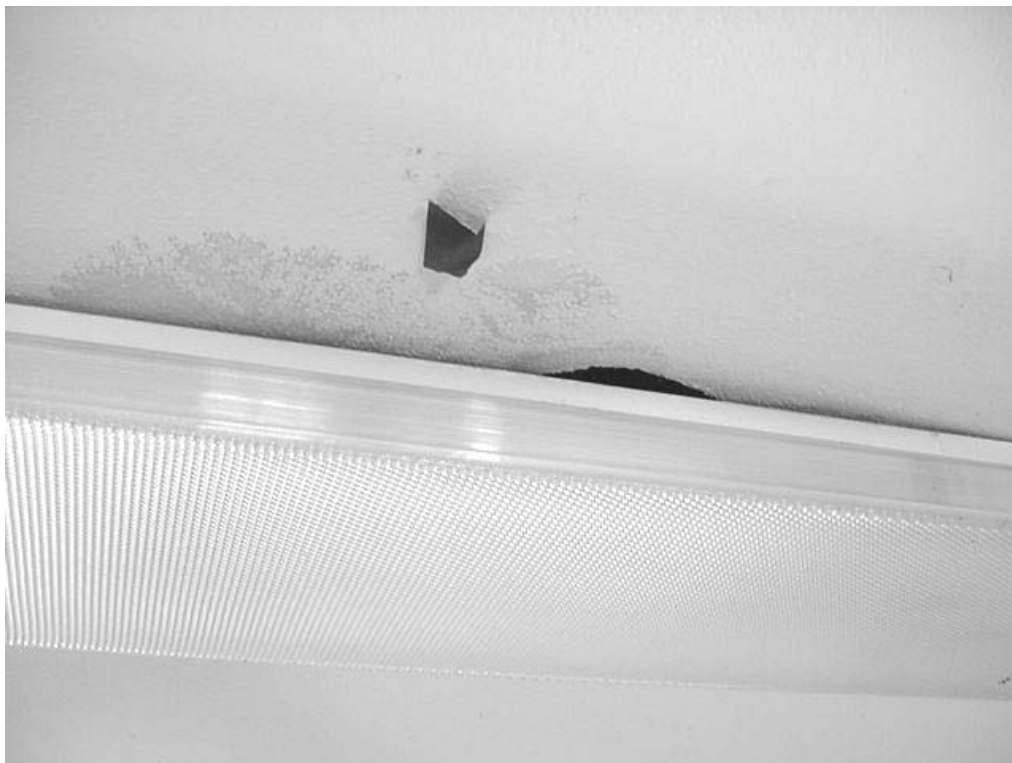
**Picture 5**

- Building occupants report a history of roof leaks in the building. Water damaged flooring, ceiling and wall plaster was observed in several areas (see Pictures 5 & 6), which is evidence of roof or plumbing leaks. Water-damaged building materials can serve as mold growth media, and should be replaced/repared after a water leak is discovered.

**Water Damaged Ceiling Plaster in Classroom**

3. Report any signs of water penetration to building owner/management for prompt remediation.
4. Repair active roof leaks. Once repaired, replace any remaining water-damaged building materials. Examine the areas above and behind these tiles for mold growth. Disinfect areas of water leaks with an appropriate antimicrobial.

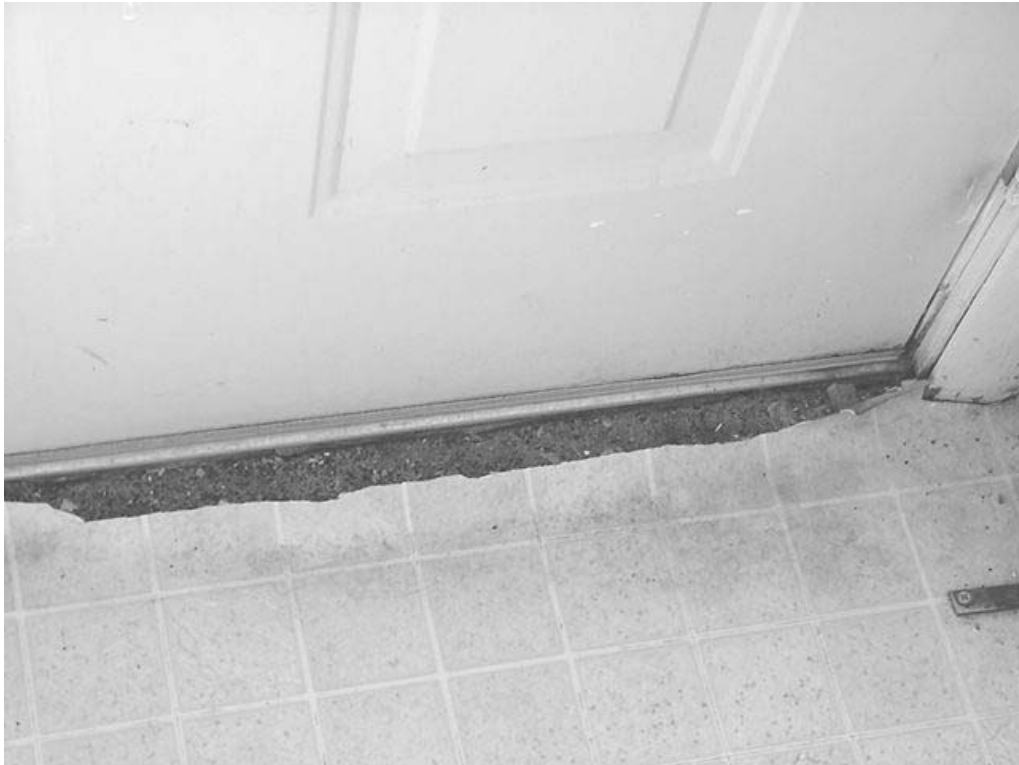
**Picture 6**

**Water Damaged Flooring around Main Entrance**
